Potential Pathogens and Total Phosphorus **ANNUAL REPORT**

Water Quality Monitoring (WQM) Program

2025 POTENTIAL PATHOGENS AND TOTAL PHOSPHORUS ANNUAL REPORT

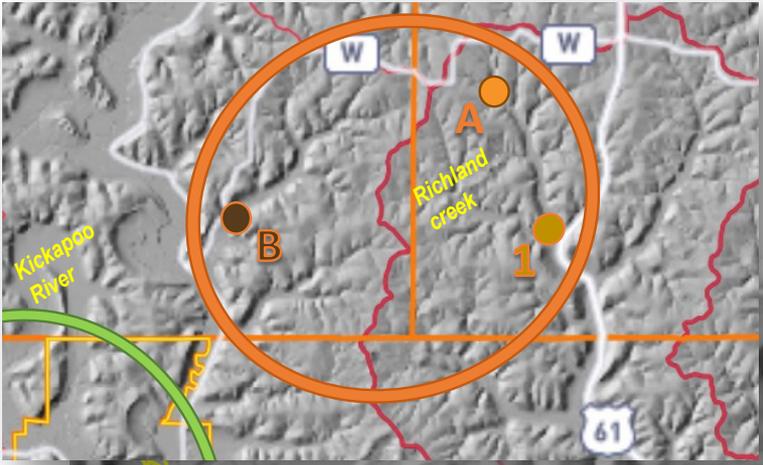
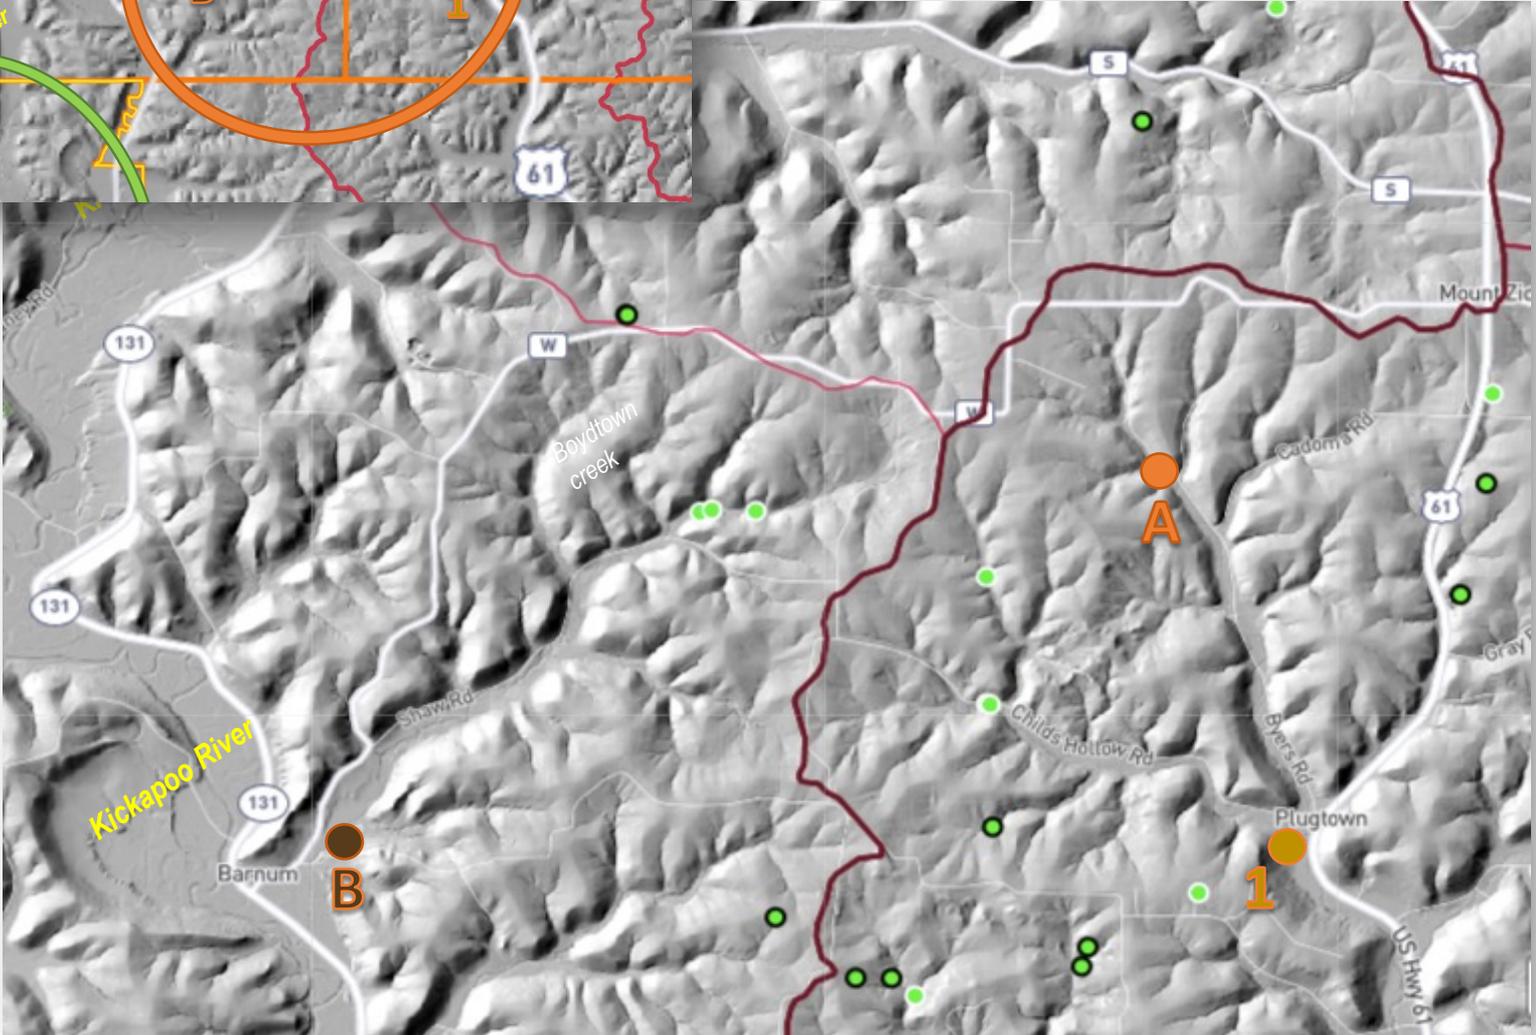
ZONE 1: Site location map

- Watershed boundary
- Sub-watershed boundary
- Possible sinkhole*
- Probable sinkhole*

* As identified by CSP's Karst Landscapes and Groundwater Susceptibility Survey of Crawford Co.

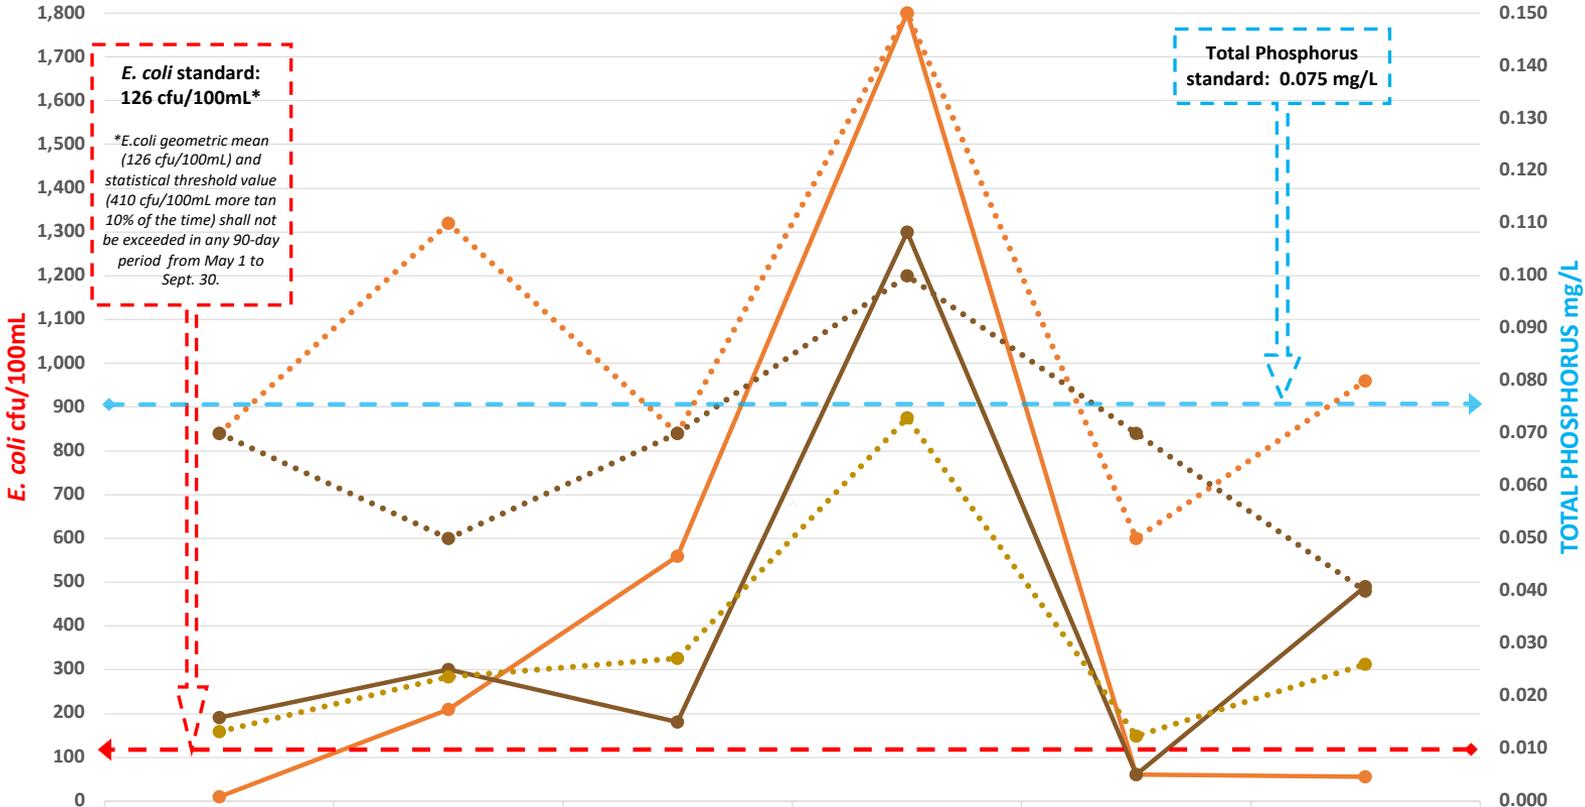
ZONE 1: E. coli AND TOTAL PHOSPHORUS RESULTS, 2025
STATION A: #10044917 (Richland Creek at Byers Road)
STATION B: #10056913 (Unnamed Trib (1183600) at Drake Rd)
STATION 1 - DNR: #10044131 (Richland Creek – Childs Hollow Rd Bridge)

- Comments:
- Highest precipitation levels in the month of August since 2019
 - Constant and very high levels of E. coli, Total Phosphorus, Staphylococcus specie and/or background bacteria found on all stations

May-25	June-25	July-25	August-25	September-25	October-25
—●— E. coli, Station A: #10044917	10	210	560	1,800	60	55
—●— E. coli, Station B: #10056913	190	300	180	1,300	60	490
—●— TP, Station A: #10044917	0.070	0.110	0.070	0.150	0.050	0.080
—●— TP, Station B: #10056913	0.070	0.050	0.070	0.100	0.070	0.040
—●— TP, Station 1: #10044131	0.0132	0.0236	0.0272	0.0730	0.0124	0.0260

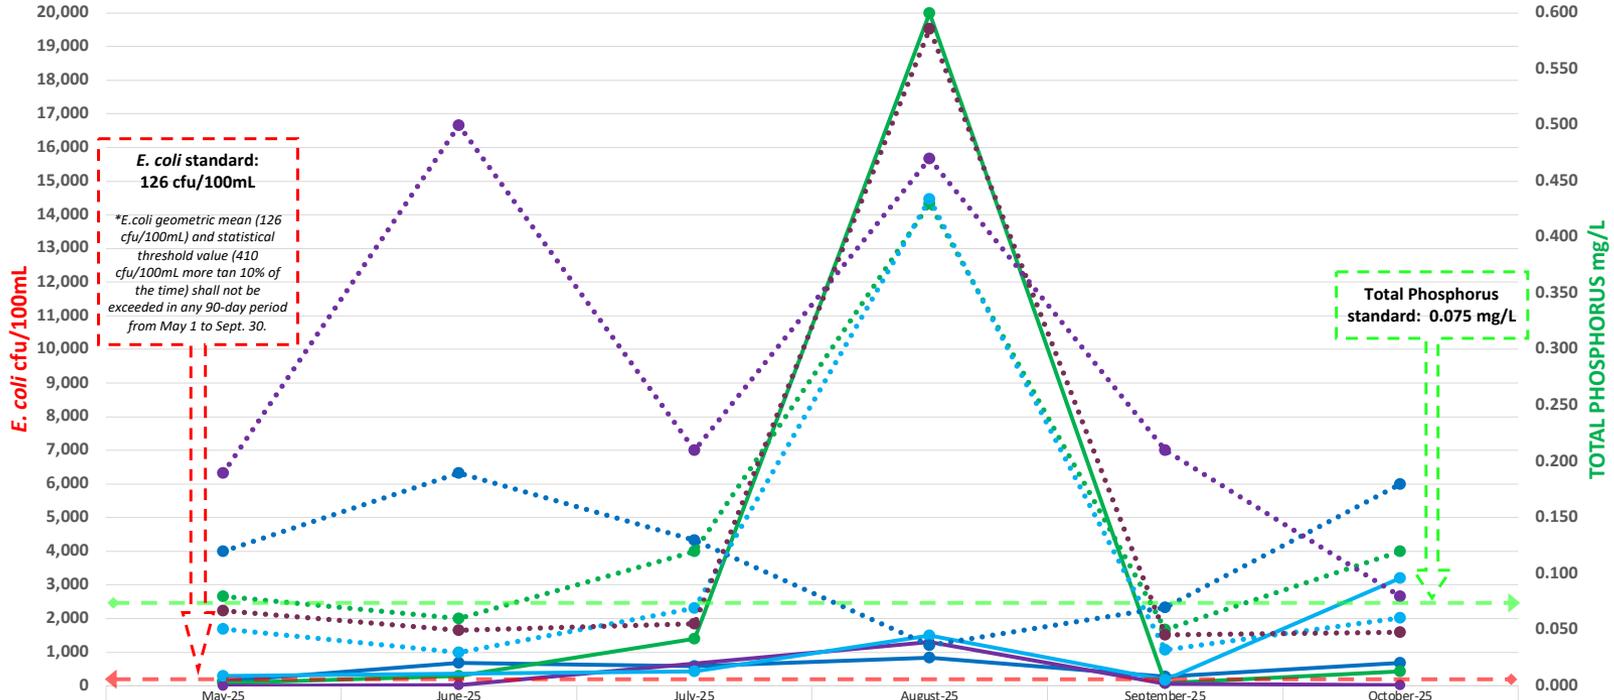
- Comments:
- Highest precipitation levels in the month of August since 2019
 - Constant and very high levels of E. coli, Total Phosphorus, Staphylococcus specie and/or background bacteria found on all stations
 - Alarming levels of Staphylococcus aureus (6,000/100 mL) found on STATION E (spring #10052569) in September

May-25	June-25	July-25	August-25	September-25	October-25
● E. coli, Station C: #10032119	140	690	580	830	270	690
● E. coli, Station D: #10032123	80	300	1,400	20,000	80	420
● E. coli, Station E: #10052569	10	30		1,300	60	32
● E. coli, Station 2: #10013610	300		420	1,500	170	3,200
● TP, Station C: #10032119	0.120	0.190	0.130	0.036	0.070	0.180
● TP, Station D: #10032123	0.080	0.060	0.120	0.430	0.050	0.120
● TP, Station E: #10052569	0.190	0.500	0.210	0.470	0.210	0.080
● TP, Station 2: #10013610	0.0506	0.0295	0.0696	0.4340	0.0319	0.0605
● TP, Station 3: #10029558	0.0669	0.0497	0.0555	0.5860	0.0453	0.0477

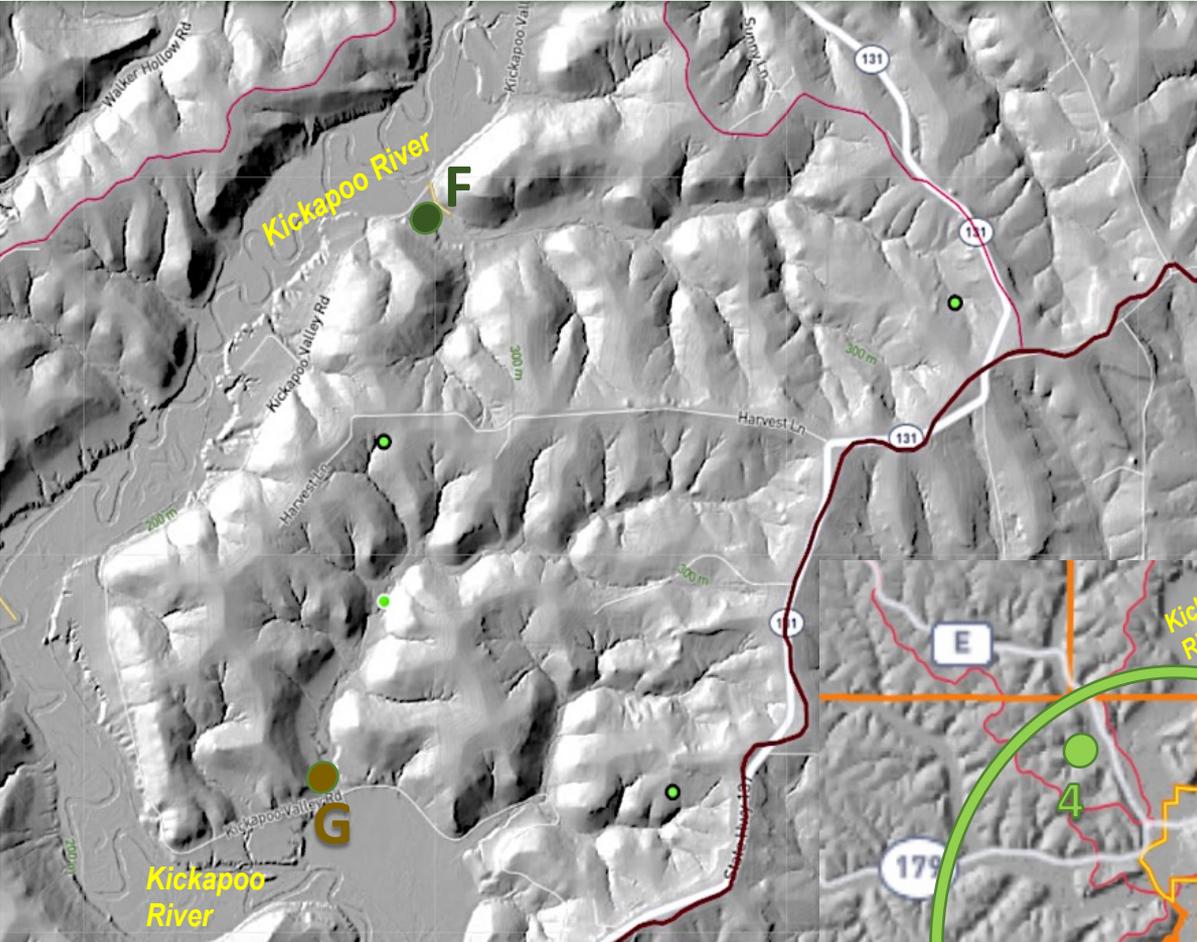
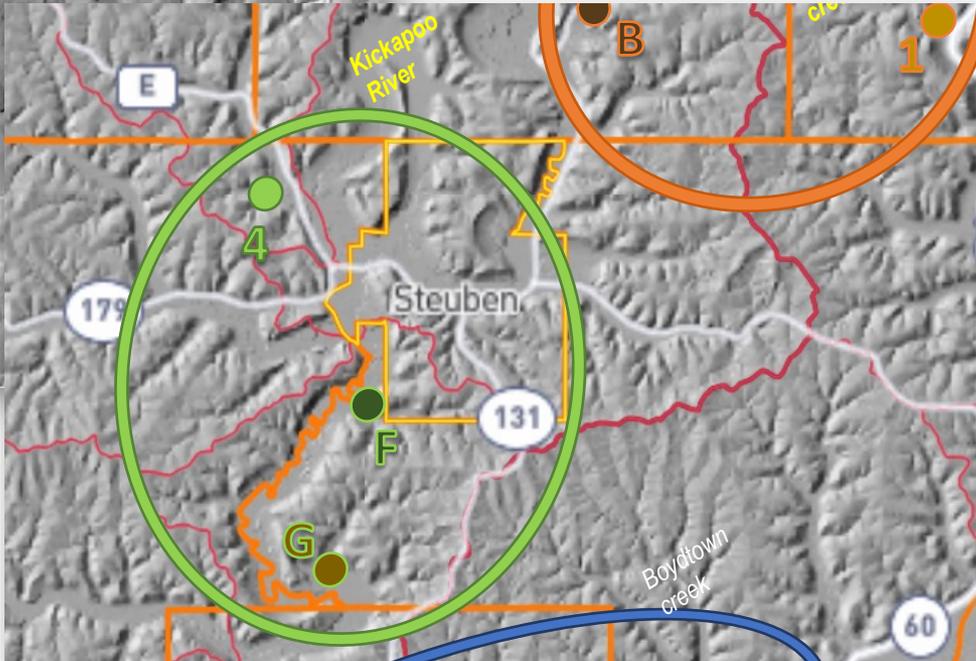
ZONE 3: Site location maps

- Watershed boundary
- Sub-watershed boundary
- Possible sinkhole*
- Probable sinkhole*

* As identified by CSP's Karst Landscapes and Groundwater Susceptibility Survey of Crawford Co.

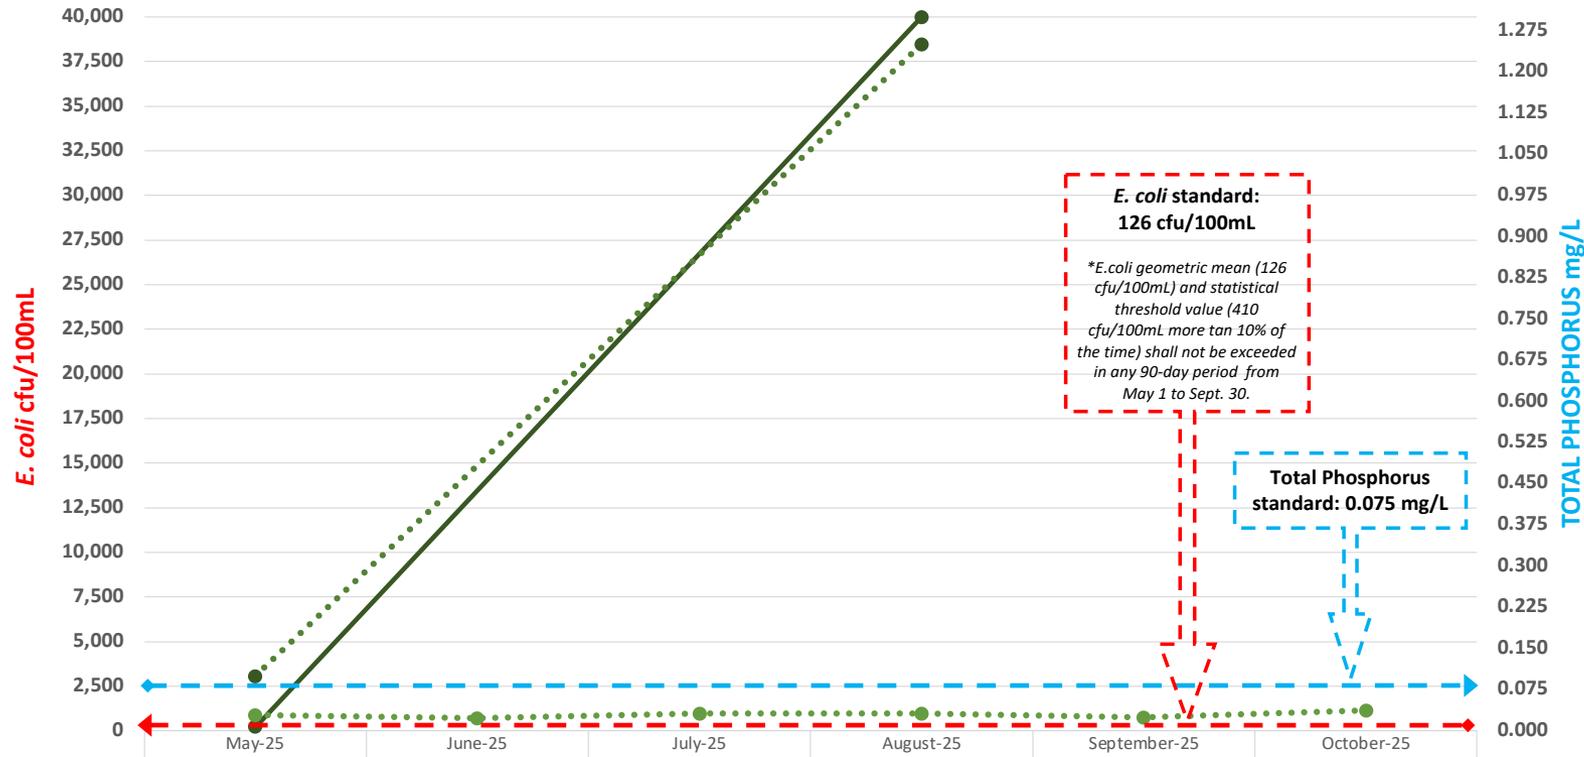
ZONE 3: E. coli AND TOTAL PHOSPHORUS RESULTS, 2025

- Highest precipitation levels in the month of August since 2019
- STATION F (#10052670) was only active in May and August.; STATION G (#10052671) was dry the whole season
- Alarming levels of E. coli (40,000 cfu/100mL) and/or Total Phosphorus (1.25 mg/L) found on STATION F (#10052670)

STATION F: #10052670 (Unnamed (5034616) at Kickapoo Valley Road)
STATION G: #10052671 (Unnamed (5034666) at Kickapoo Valley Road)
STATION 4 - DNR: #10009025 (Citron Creek #1 Bridge on Cty E)

● E. coli, Station F: #10052670	190			40,000		
● E. coli, Station G: #10052671						
● TP, Station F: #10052670	0.100			1.250		
● TP, Station G: #10052671						
● TP, Station 4: #10009025	0.0279	0.0232	0.0313	0.0309	0.0237	0.0372
